Effects of the 2013 Rim Fire on Fine Sediment Storage, Large Wood Storage, and Vegetation Establishment in the Hetch Hetchy Reach of the Tuolumne River.

The San Francisco Public Utilities Commission Upper Tuolumne River Ecosystem Program

John H. Bair¹, Brian Powell¹, William A. Sears² and Scott M. McBain¹

Upper Tuolumne River Ecosystem Program Post Rim Fire Monitoring

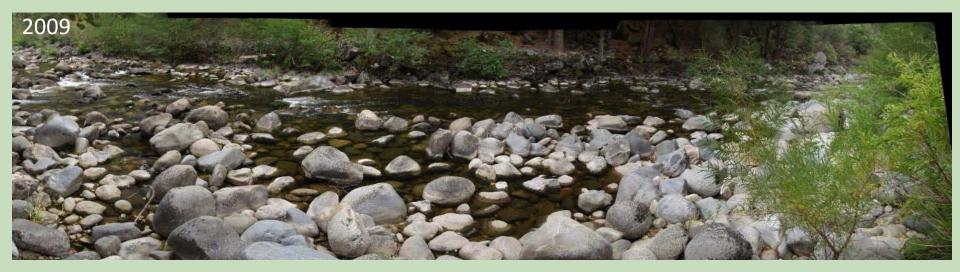
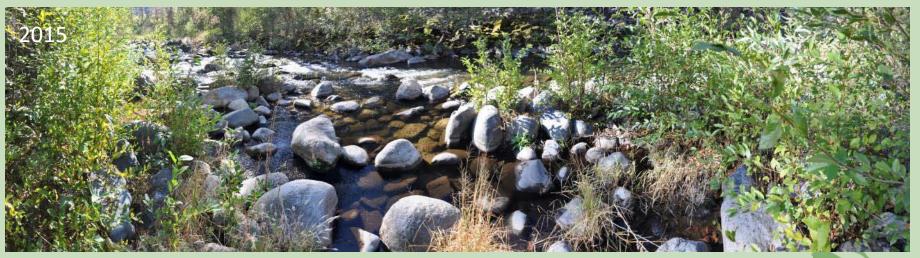
PPT 1469+50 above Early Intake woody plant encroachment

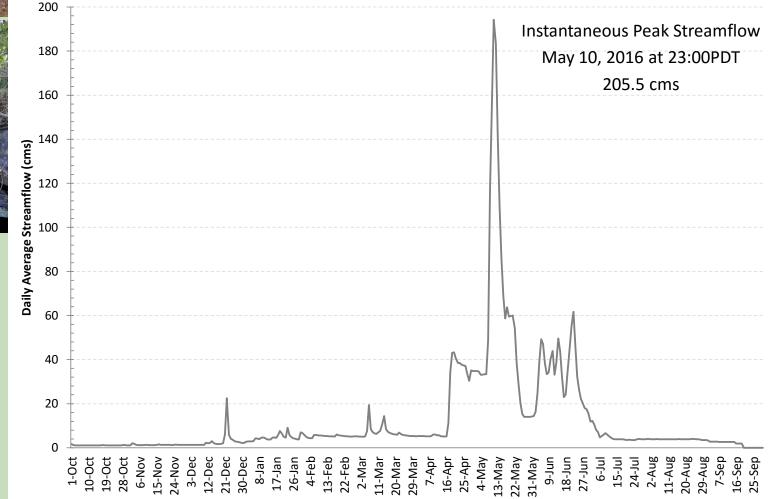
Tuolumne River streamflows above Early Intake near Mather (USGS Gage#11-276600)

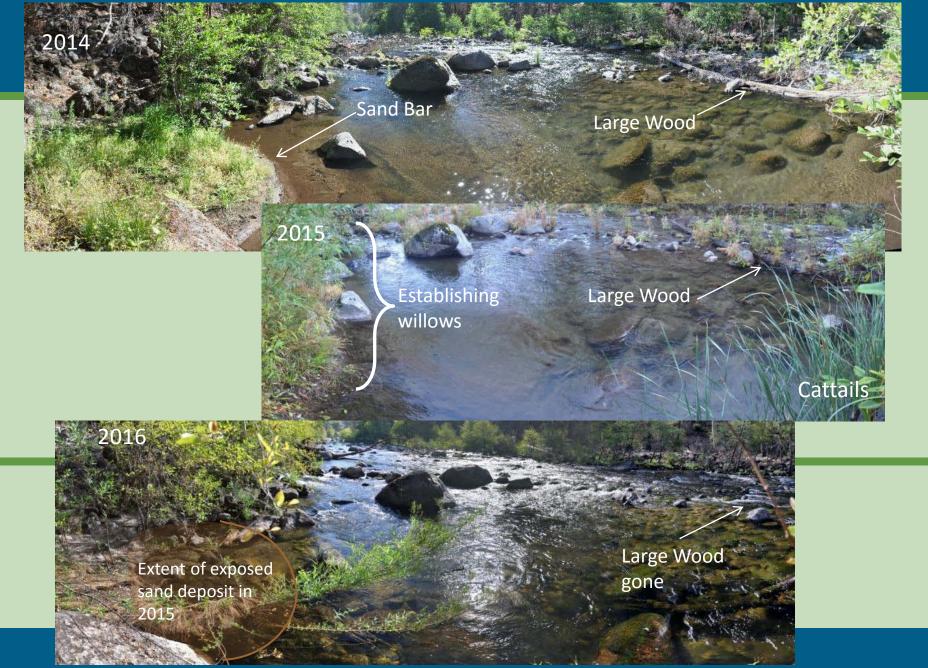
PPT 1529+30

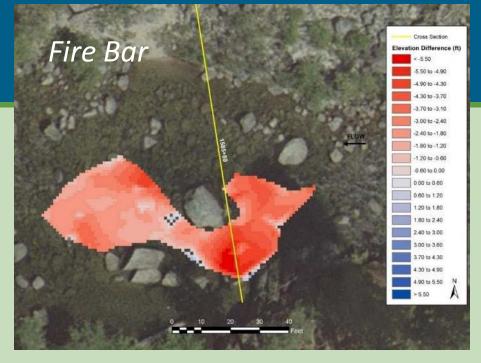
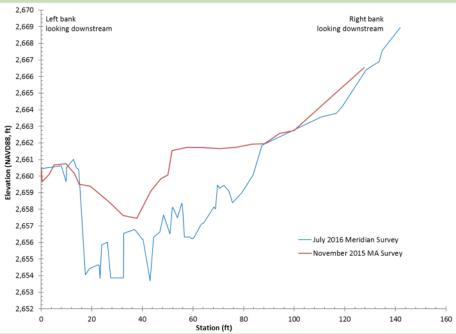
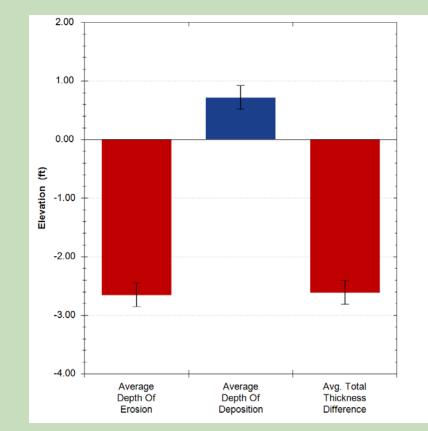
Raw	Thresholded MinLOD 0.2 ft		± Error Volume	% Error
Total Net Volume Difference (ft ³)	-4823.3	-4823.4	±	364.6	-7.6
Total Net Volume Difference (yds³)	-178.6	-178.6	±	13.5	-7.6

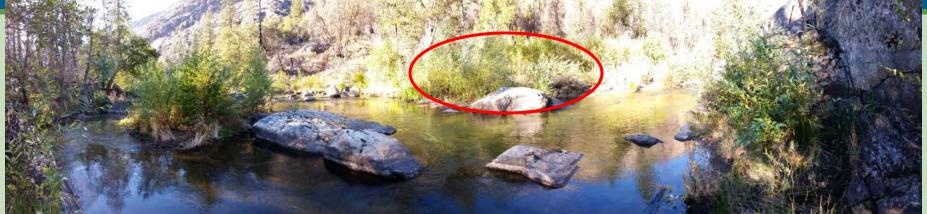
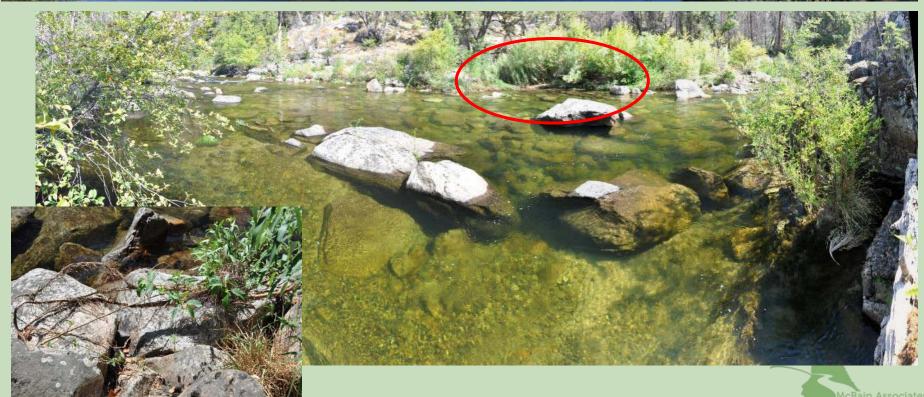
Fire Bar: larger geomorphic features where the channel was confined

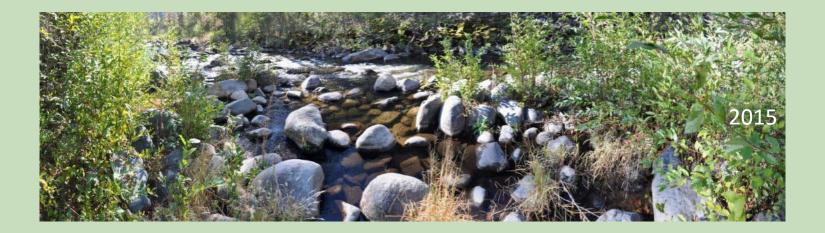
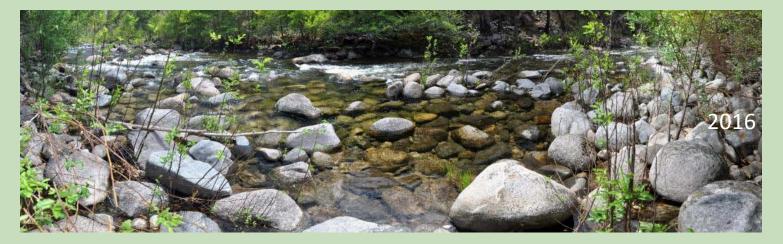
PPT 1469+50 fine sediment deposits nested in boulders

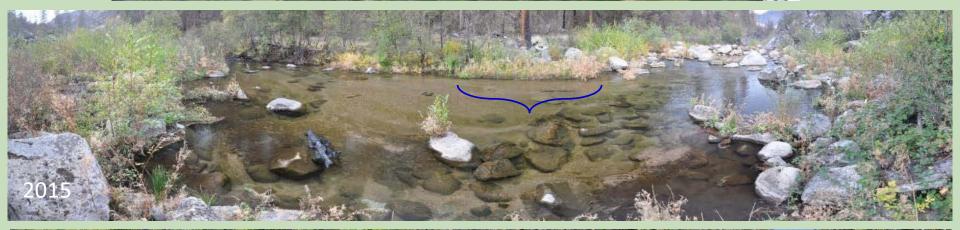
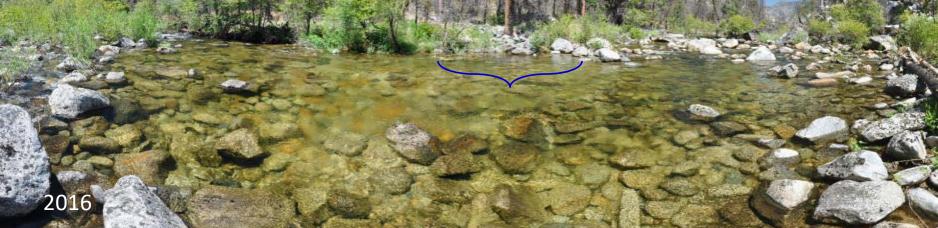
PPT 1592+25 fine sediment deposition at Mystery Bar

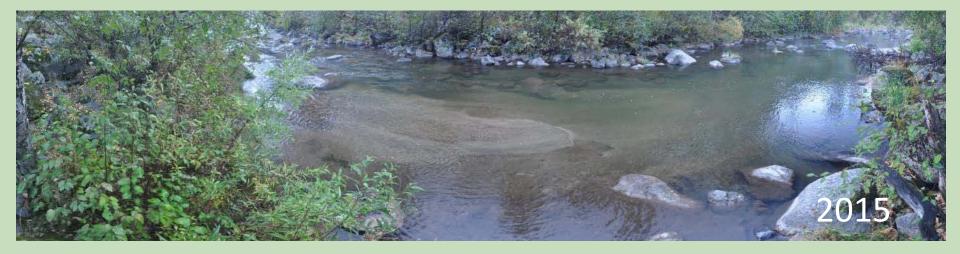
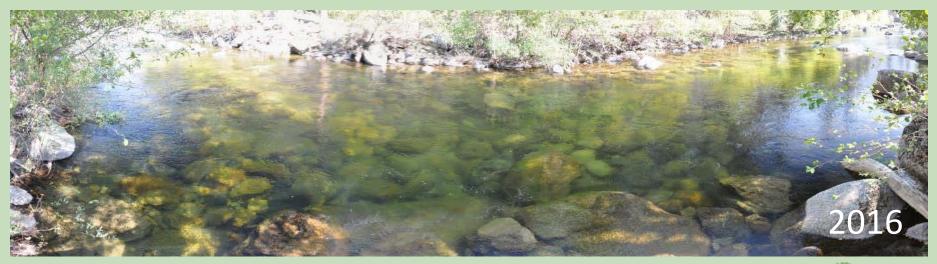
PPT 1534+75 at Driftwood Bar

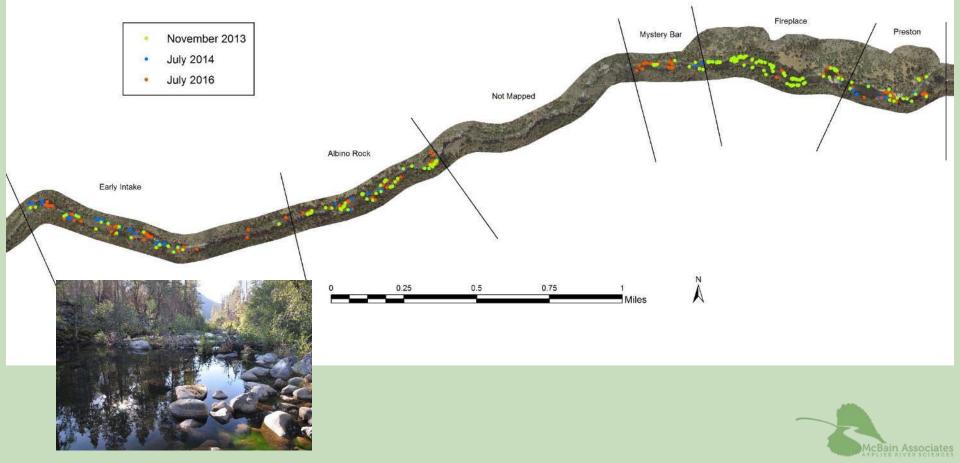
2013 – 2016 Post Rim Fire large wood loading

• Rim Fire and subsequent wind-throw and wood routing has increased the number of wood pieces (192 up to 228) and an increased in wood density (44.8 up to 53.1 p/Km) from 2013 to 2016

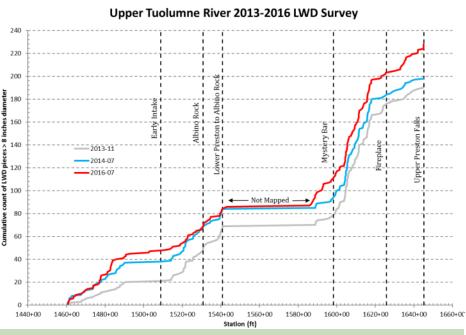
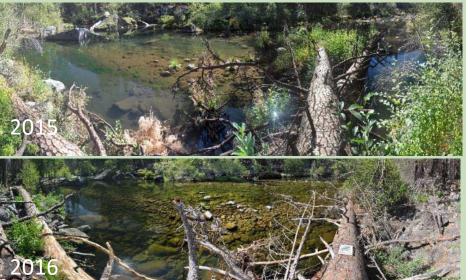
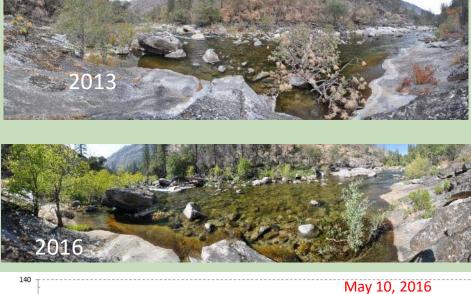
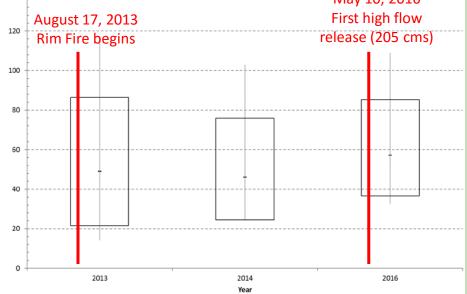
Post Rim Fire large wood loading
